This application note seeks to correct a problem that may occur when using the **In Situ Programming (ISP)** feature on **ST7MDT1-DVP2** and **ST7MDT2-DVP2** development kits.

## Workaround to ISP Mode Limitation on the ST7MDT1-DVP2 and ST7MDT2-DVP2

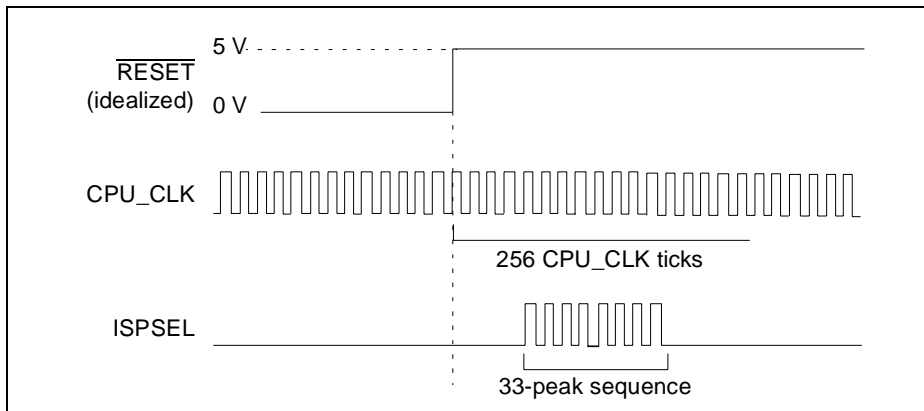
**Figure 1: “Ideal” signal transmission at ISP mode initiation ( $\overline{\text{RESET}}$  pin has no capacitance)**

Normally, when there is no capacitance at the  $\overline{\text{RESET}}$  pin, ISP mode is initiated by the following sequence, illustrated in [Figure 1](#):

- 1 A chip reset must be performed (i.e. voltage of  $\overline{\text{RESET}}$  pin falls to zero) then released, so that the voltage of the  $\overline{\text{RESET}}$  pin returns to 5 V.
- 2 The moment that the reset is released, the target MCU starts counting a period of 256 CPU\_CLK timer ticks.
- 3 Shortly after the  $\overline{\text{RESET}}$  is released, and independent of the  $\overline{\text{RESET}}$  pin's voltage, a specific 33-peak signal sequence is sent to the dedicated ISPSEL pin.

- 4 If the ISPSEL signal is received in its entirety during the 256 CPU\_CLK timer ticks after the reset release, the MCU to be programmed will enter ISP mode, and programming may begin.

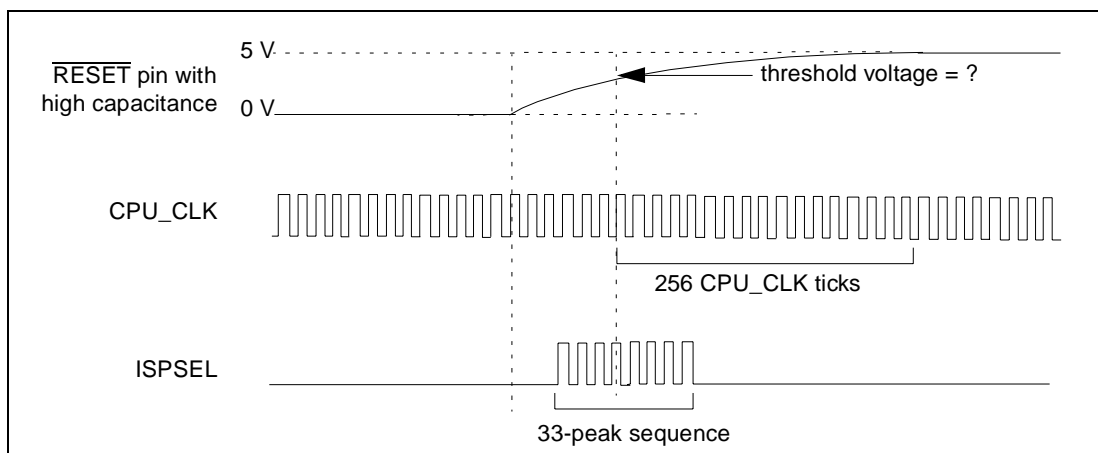
**Figure 2: Signal transmission when  $\overline{\text{RESET}}$  pin has high capacitance**

The problem arises when (for various worthy reasons) you have designed your application board with protections that result in a high capacitance at the target MCU’s  $\overline{\text{RESET}}$  pin. The result is that following a chip reset, the return of the pin to 5 V can be very gradual, rather than instantaneous.

As the voltage gradually rises at the  $\overline{\text{RESET}}$  pin, at some unknown threshold voltage (probably in the vicinity of 3.5 V, but this is dependent on several factors), the target MCU begins to count out 256 CPU\_CLK timer ticks, during which time the MCU is “listening” for the ISPSEL signal.

However, because the ISPSEL signal sequence is sent from the ISP driver independently of the  $\overline{\text{RESET}}$  pin value, in a high capacitance scenario it becomes very likely that the 33-peak ISPSEL signal sequence will begin transmission before the MCU is ready to receive it (i.e. before the voltage on the  $\overline{\text{RESET}}$  pin has reached its threshold value). [Figure 2](#) illustrates this sequence of events.

The result is that the target MCU doesn’t receive the ISPSEL signal sequence in its entirety and therefore cannot be put into ISP mode to accept programming.

The first way to ensure that ISP mode functions correctly is to design your application board so that the RESET pin has low capacitance.

However, we recognize that this isn't always possible, and so have provided a workaround involving the following three steps:

- 1 Updating your version of WINEE (Windows Epromer) to version 4.0.
- 2 Modification to the DVP hardware—linking several pins of the ISP driver chip together by soldering two wires.
- 3 Reprogramming the ISP driver firmware.

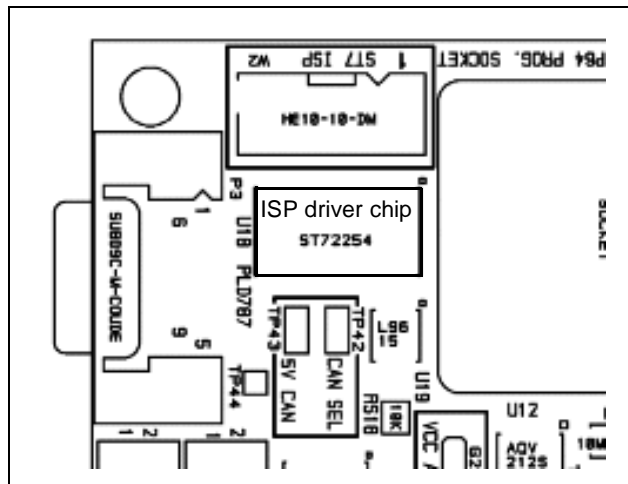
Figure 3: Location of ISP driver chip on the ST7MDT2-DVP2

- 1 Locate the ISP driver chip (ST72254), in the corner of the DVP board, close to the ISP connector. *Figure 3* shows the location of the driver chip (labelled U18) for the ST7MDT2-DVP2. The driver chip is in a similar location (labelled U17) on the ST7MDT1-DVP2.
