### STM32F100x4, STM32F100x6, STM32F100x8 and STM32F100xB low and medium-density value line device limitations

## Silicon identification

This errata sheet applies to the revision Z of the STMicroelectronics low and medium-density STM32F100xx value line products.

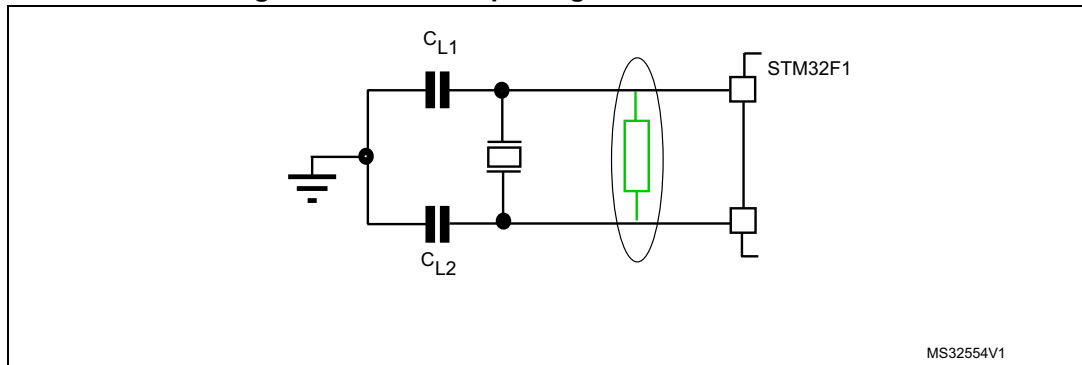
Figure 1. LSE start-up using an additional resistor

The LSE (Low Speed External) oscillator system has been designed to minimize the overall power consumption of the STM32F1 microcontroller. It is extremely important to take specific care in the design of the PCB to ensure this low power oscillator starts in harsh conditions. In some PCB designs without coating, an induced low leakage may prevent the LSE to start-up, regardless of the 32.768 KHz crystal used. This phenomenon is amplified in humid environments that create frost on the OSC32\_IN/OSC32\_OUT tracks. This unwanted behavior may happen only at the first back-up domain power-on of the device.

It is recommended to mount an additional parallel feedback resistor (from 16 MΩ to 22 MΩ) on board to help the oscillation start-up in all cases (see [Figure 1](#)). For more details on compatible crystals and hardware techniques on PCB, refer to AN2867 "Oscillator design guide for STM8AF/AL/S, STM32 MCUs and MPUs" available on [www.st.com](http://www.st.com).
