STM32F100xC, STM32F100xD and STM32F100xE high-density value line device limitations

This errata sheet applies to the revision A of the STMicroelectronics high-density value line products.

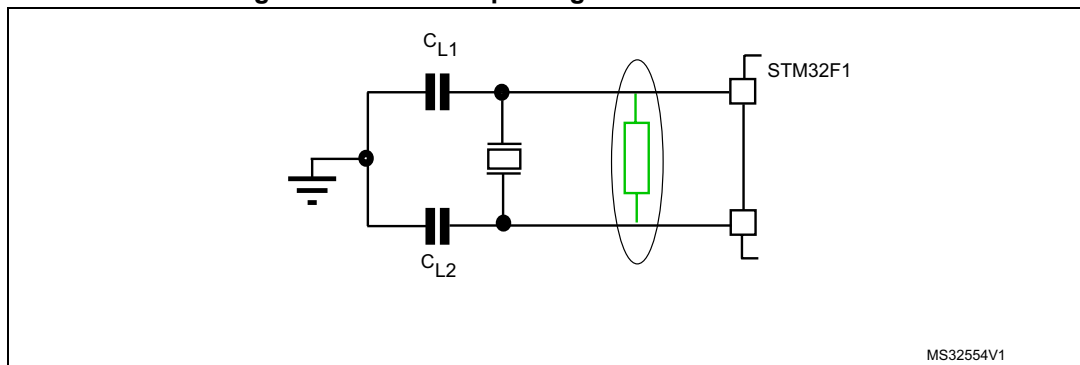
Figure 1. LSE start-up using an additional resistor

The LSE (low speed external) oscillator system is designed to minimize the overall power consumption of the STM32F1 microcontroller. It is extremely important to take specific care in the design of the PCB to ensure this low power oscillator starts in harsh conditions. In some PCB designs without coating, an induced low leakage may prevent the LSE to start-up, regardless of the 32.768 KHz crystal used. This phenomenon is amplified in humid environments that create frost on the OSC32_IN/OSC32_OUT tracks. This unwanted behavior may happen only at the first back-up domain power-on of the device.

It is recommended to mount an additional parallel feedback resistor (from 16 M Ω to 22 M Ω) on board to help the oscillation start-up in all cases (see [Figure 1](#)). For more details on compatible crystals and hardware techniques on PCB, refer to AN2867 "Oscillator design guide for STM8AF/AL/S, STM32 MCUs and MPUs", available on www.st.com.
