STM32F051x4/x6/x8 device errata

Applicability

This document applies to the part numbers of STM32F051x4/x6/x8 devices and the device variants as stated in this page. It gives a summary and a description of the device errata, with respect to the device datasheet and reference manual RM0091. Deviation of the real device behavior from the intended device behavior is considered to be a device limitation. Deviation of the description in the reference manual or the datasheet from the intended device behavior is considered to be a documentation erratum. The term “*errata*” applies both to limitations and documentation errata.

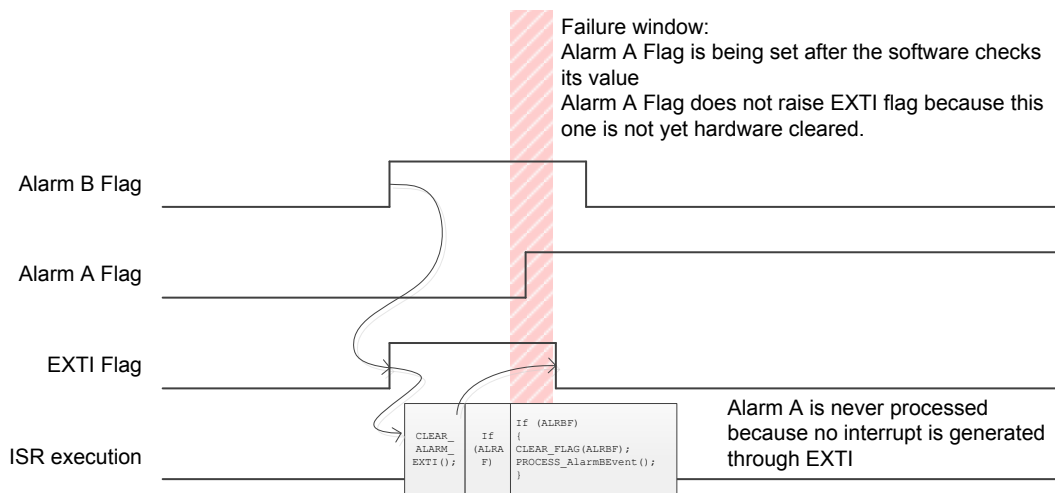
Figure 1. Masked RTC interrupt

The following code example and figure illustrate the failure mechanism: The Alarm A event is lost (fails to generate interrupt) as it occurs in the failure window, that is, after checking the Alarm A event flag but before the effective clear of the EXTI interrupt flag by hardware. The effective clear of the EXTI interrupt flag is delayed with respect to the software instruction to clear it.

Workaround

In the interrupt service routine, apply three consecutive event flag checks - source one, source two, and source one again, as in the following code example:

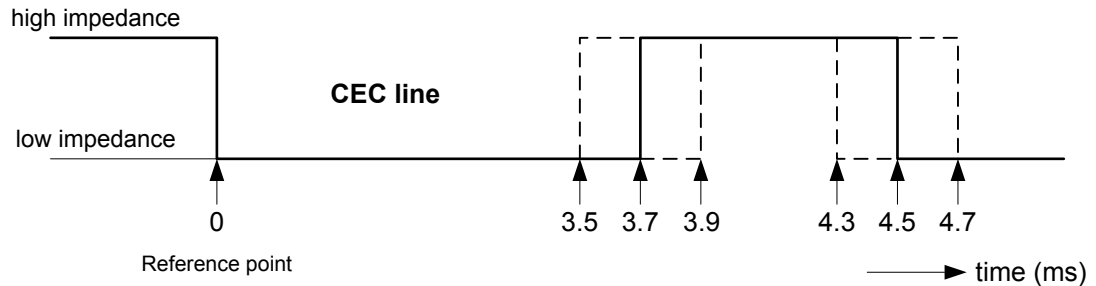
Figure 2. HDMI-CEC start bit format with tolerances

The start bit timing standard tolerances are shown in the following figure. The start bit is initiated by the device by driving the CEC line low (reference point). After 3.7 ms, the device releases the CEC line and starts checking its level. The following conditions must be met for the start bit to be valid:

If one of these conditions is not met, the transmission is aborted and never automatically retried. No error flag is set and the TXSOM (Tx start of message) bit is not cleared.

Workaround

The only way to detect this error is for the application software to start a timeout when setting the TXSOM bit, restart it upon ARBLST or any RX event (as the transmission can be delayed by interleaved reception), and stop it upon TXBR (proof that the start bit was transmitted successfully) or TXEND event, or upon any TX error (which clears TXSOM). If the timeout expires (because none of those events occurred), the application software must restart the HDMI-CEC peripheral and retransmit the message.
