Applicability

This document applies to the part numbers of STM32F038x6 devices listed in [Table 1](#) and their variants shown in [Table 2](#).

[Section 1](#) gives a summary and [Section 2](#) a description of device limitations and documentation errata, with respect to the device datasheet and reference manual RM0091.

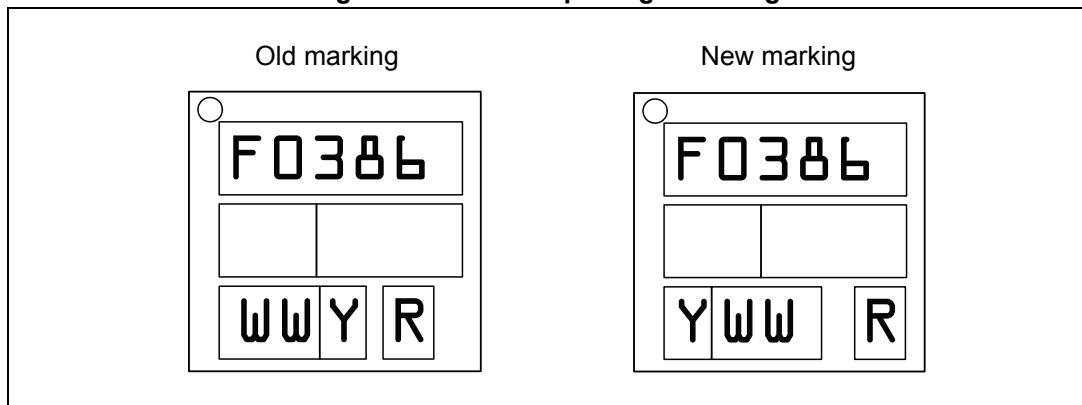
Figure 2. WLCSP25 package marking

From week 9, 2017 on, the marking on the WLCSP25 package is modified to show the date in the format YWW. [Figure 2](#) illustrates the difference between the old and the new product marking. The figure in the product datasheet was also updated to better reflect the dimensions and layout of the marking on the package.
