## STM32F070x6/xB device errata

This document applies to the part numbers of STM32F070x6/xB devices and the device variants as stated in this page.

It gives a summary and a description of the device errata, with respect to the device datasheet and reference manual RM0360.

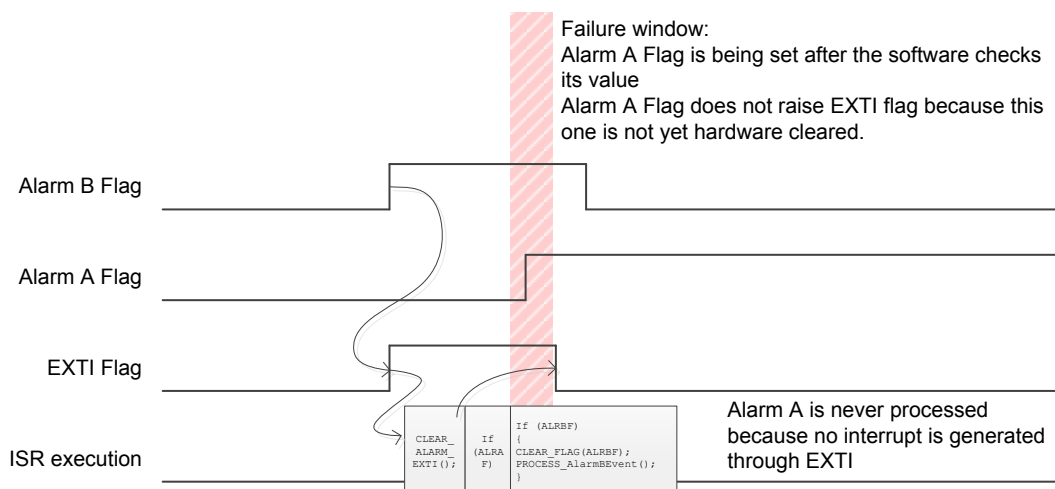
Figure 1. Masked RTC interrupt

The following code example and figure illustrate the failure mechanism: The Alarm A event is lost (fails to generate interrupt) as it occurs in the failure window, that is, after checking the Alarm A event flag but before the effective clear of the EXTI interrupt flag by hardware. The effective clear of the EXTI interrupt flag is delayed with respect to the software instruction to clear it.

### Workaround

In the interrupt service routine, apply three consecutive event flag checks - source one, source two, and source one again, as in the following code example:
