Applicability

This document applies to the part numbers of STM32L471xx devices listed in [Table 1](#) and their variants shown in [Table 2](#).

[Section 1](#) gives a summary and [Section 2](#) a description of workarounds for device limitations, with respect to the device datasheet and reference manual RM0351.

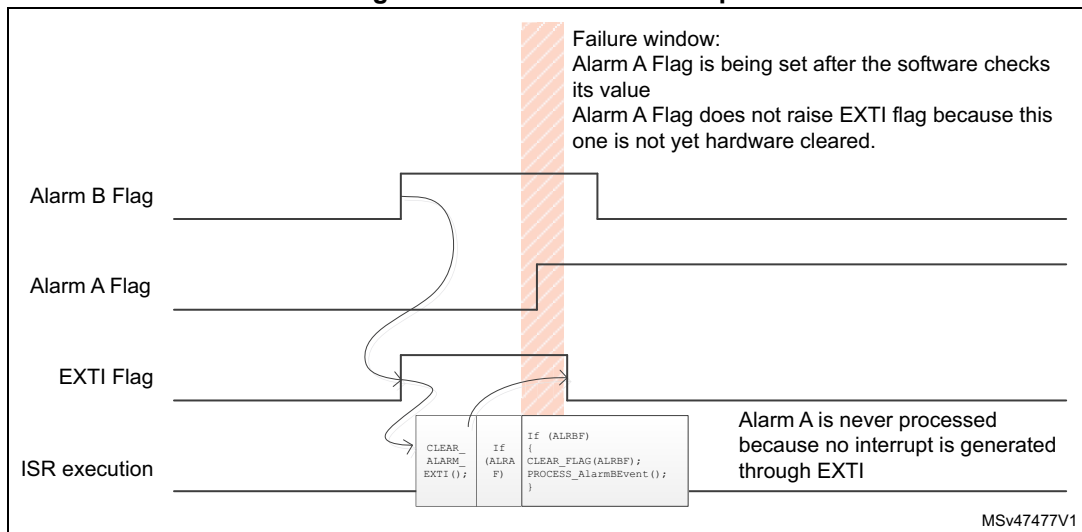
Figure 3. Masked RTC interrupt

The following code example and figure illustrate the failure mechanism: The Alarm A event is lost (fails to generate interrupt) as it occurs in the failure window, that is, after checking the Alarm A event flag but before the effective clear of the EXTI interrupt flag by hardware. The effective clear of the EXTI interrupt flag is delayed with respect to the software instruction to clear it.

In the interrupt service routine, apply three consecutive event flag checks - source one, source two, and source one again, as in the following code example:
