STM32L4Rxxx and STM32L4Sxxx device errata

This document applies to the part numbers of STM32L4Rxxx and STM32L4Sxxx devices and the device variants as stated in this page.

It gives a summary and a description of the device errata, with respect to the device datasheet and reference manual RM0432.

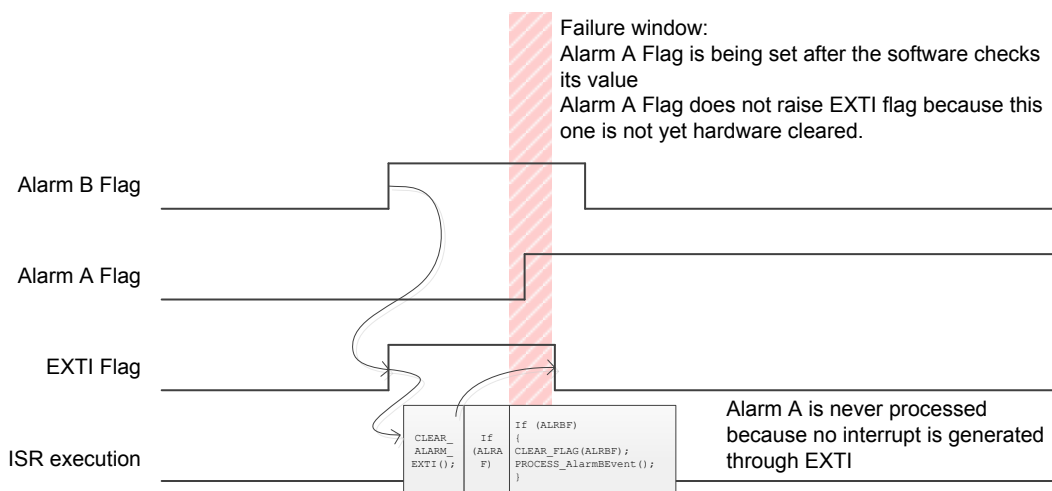
Figure 1. Masked RTC interrupt

The following code example and figure illustrate the failure mechanism: The Alarm A event is lost (fails to generate interrupt) as it occurs in the failure window, that is, after checking the Alarm A event flag but before the effective clear of the EXTI interrupt flag by hardware. The effective clear of the EXTI interrupt flag is delayed with respect to the software instruction to clear it.

In the interrupt service routine, apply three consecutive event flag checks - source one, source two, and source one again, as in the following code example:
