Applicability

This document applies to the part numbers of STM32L471xx devices listed in [Table 1](#) and their variants shown in [Table 2](#).

[Section 1](#) gives a summary and [Section 2](#) a description of workarounds for device limitations, with respect to the device datasheet and reference manual RM0351.

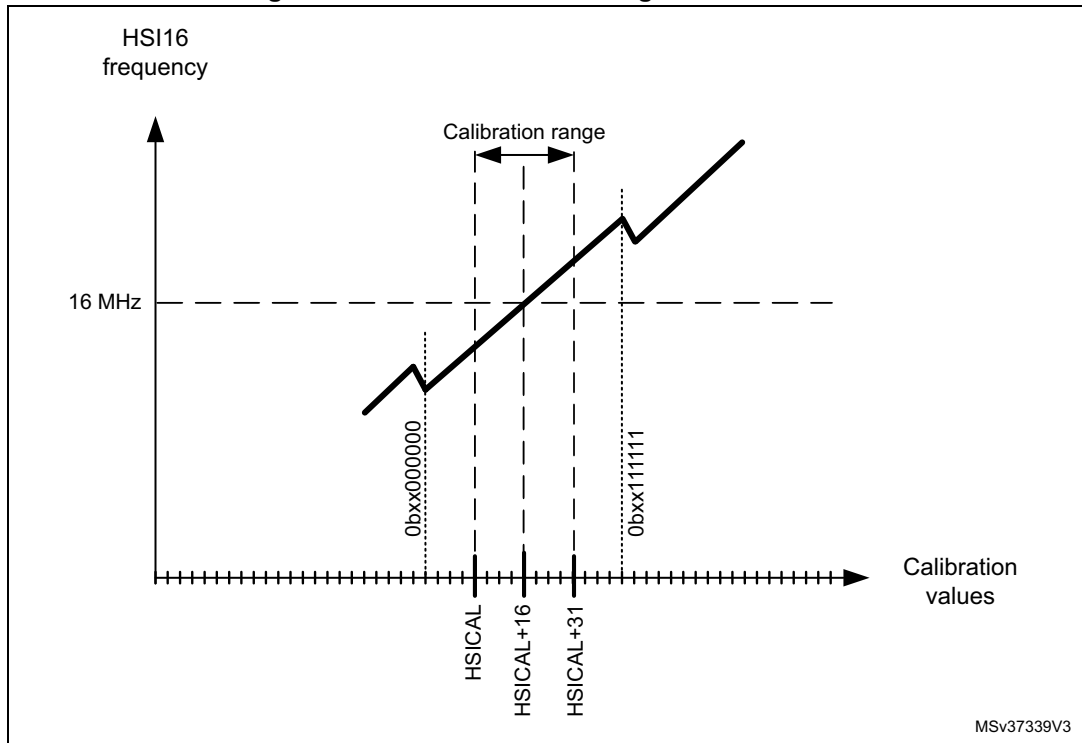
Figure 1. HSI oscillator trimming characteristics

Consequently, the user trim correction must not jump over the codes multiple of 64, which can limit the user correction either in positive or in negative direction.

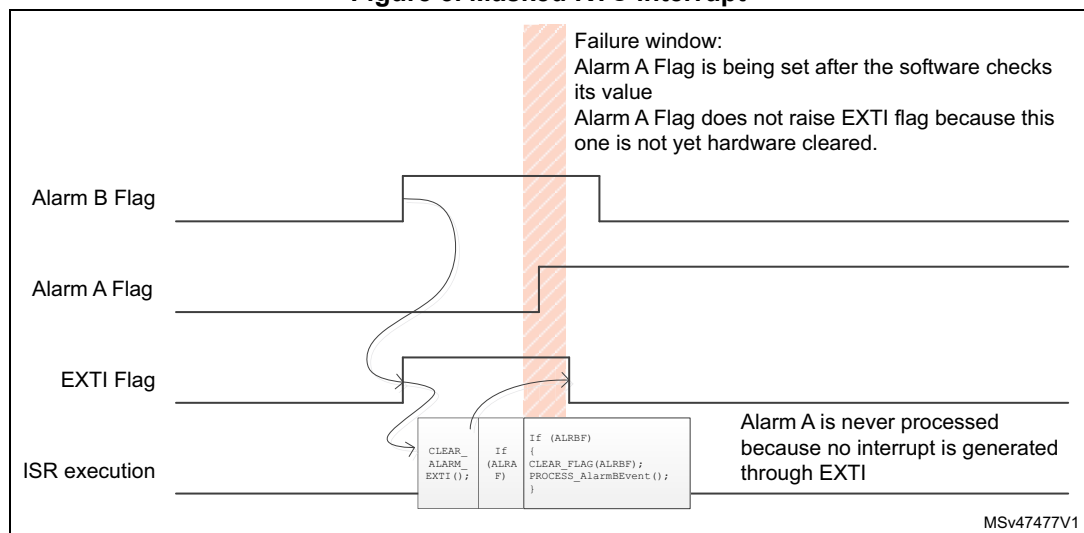
Figure 3. Masked RTC interrupt

The following code example and figure illustrate the failure mechanism: The Alarm A event is lost (fails to generate interrupt) as it occurs in the failure window, that is, after checking the Alarm A event flag but before the effective clear of the EXTI interrupt flag by hardware. The effective clear of the EXTI interrupt flag is delayed with respect to the software instruction to clear it.

In the interrupt service routine, apply three consecutive event flag checks - source one, source two, and source one again, as in the following code example:
