## STM32L431xx device errata

This document applies to the part numbers of STM32L431xx devices and the device variants as stated in this page.

It gives a summary and a description of the device errata, with respect to the device datasheet and reference manual RM394.

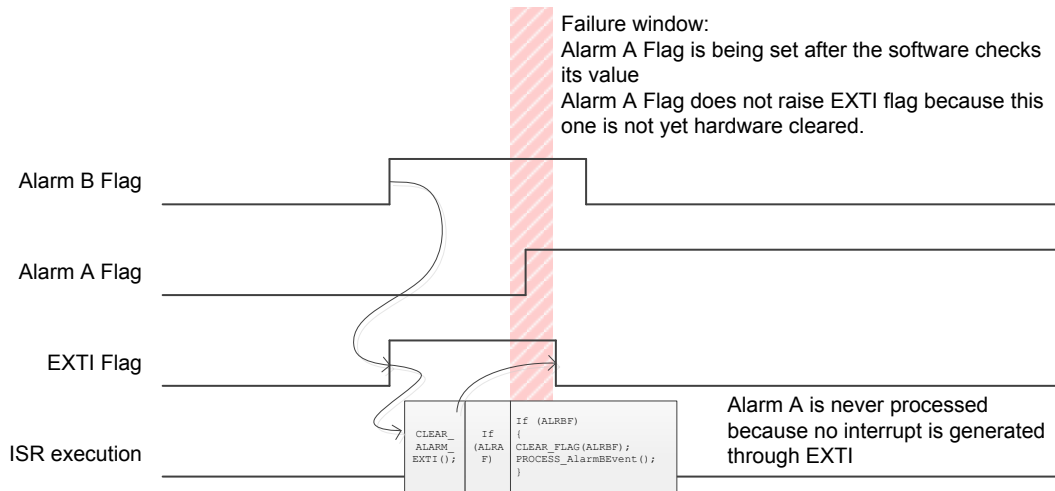
**Figure 1. Masked RTC interrupt**

The following code example and figure illustrate the failure mechanism: The Alarm A event is lost (fails to generate interrupt) as it occurs in the failure window, that is, after checking the Alarm A event flag but before the effective clear of the EXTI interrupt flag by hardware. The effective clear of the EXTI interrupt flag is delayed with respect to the software instruction to clear it.

In the interrupt service routine, apply three consecutive event flag checks - source one, source two, and source one again, as in the following code example:
