## STM32MP151x/3x/7x device errata

This document applies to the part numbers of STM32MP151x/3x/7x devices and the device variants as stated in this page.

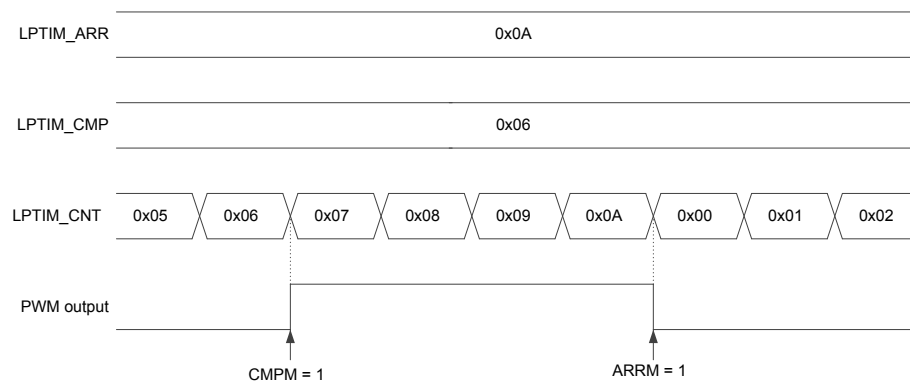
Consequently, it is not possible to generate PWM with a duty cycle of 0% or 100%.

The following waveform gives the example of PWM output mode and the effect of the delay:

Set the compare value to the desired value minus 1. For instance in order to generate a compare match when LPTIM\_CNT = 0x08, set the compare value to 0x07.
