STM32H72xx/73xx device errata

Applicability

This document applies to the part numbers of STM32H72xx/73xx devices and the device variants as stated in this page.

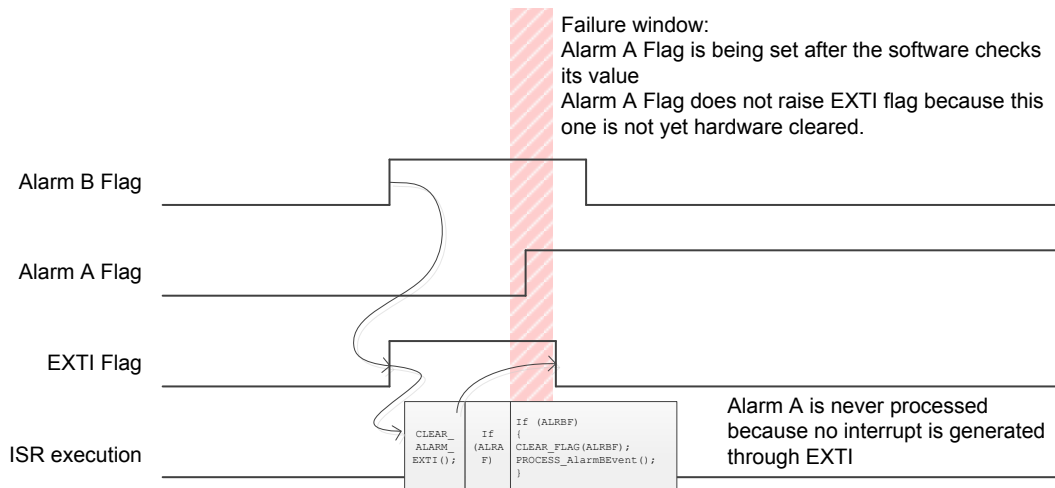
Figure 1. Masked RTC interrupt

The following code example and figure illustrate the failure mechanism: The Alarm A event is lost (fails to generate interrupt) as it occurs in the failure window, that is, after checking the Alarm A event flag but before the effective clear of the EXTI interrupt flag by hardware. The effective clear of the EXTI interrupt flag is delayed with respect to the software instruction to clear it.

In the interrupt service routine, apply three consecutive event flag checks - source one, source two, and source one again, as in the following code example:
