## STM32F058C8/R8 device errata

This document applies to STM32F058C8/R8 devices and the device variants as stated in this page.

It gives a summary and a description of the device errata, with respect to the device datasheet and reference manual RM0091.

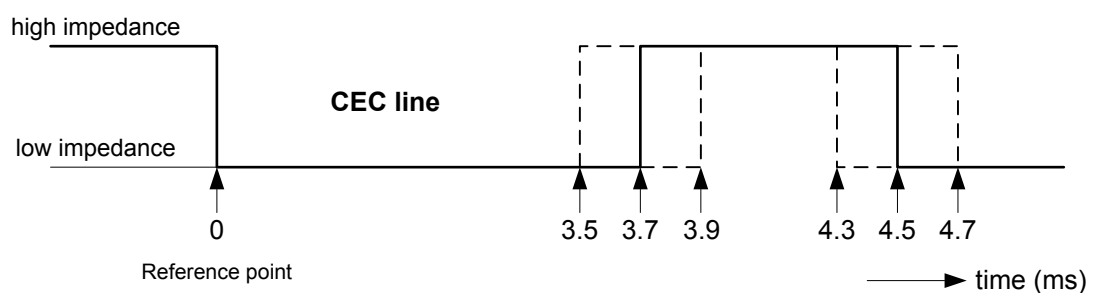
**Figure 2. HDMI-CEC start bit format with tolerances**

The start bit timing standard tolerances are shown in the following figure. The start bit is initiated by the device by driving the CEC line low (reference point). After 3.7 ms, the device releases the CEC line and starts checking its level. The following conditions must be met for the start bit to be valid:

If one of these conditions is not met, the transmission is aborted and never automatically retried. No error flag is set and the TXSOM (Tx start of message) bit is not cleared.

The only way to detect this error is for the application software to start a timeout when setting the TXSOM bit, restart it upon ARBLST or any RX event (as the transmission can be delayed by interleaved reception), and stop it upon TXBR (proof that the start bit was transmitted successfully) or TXEND event, or upon any TX error (which clears TXSOM). If the timeout expires (because none of those events occurred), the application software must restart the HDMI-CEC peripheral and retransmit the message.
